Operational Programme for Macedonia -Thrace 2007-2013

Ministry of Culture & Sports  
Ephorate of Antiquities of Chalcidice & Mount Athos

# SIDIROKAUSIA Ottoman Hamam

## Ottoman Hamam – Conservation Works

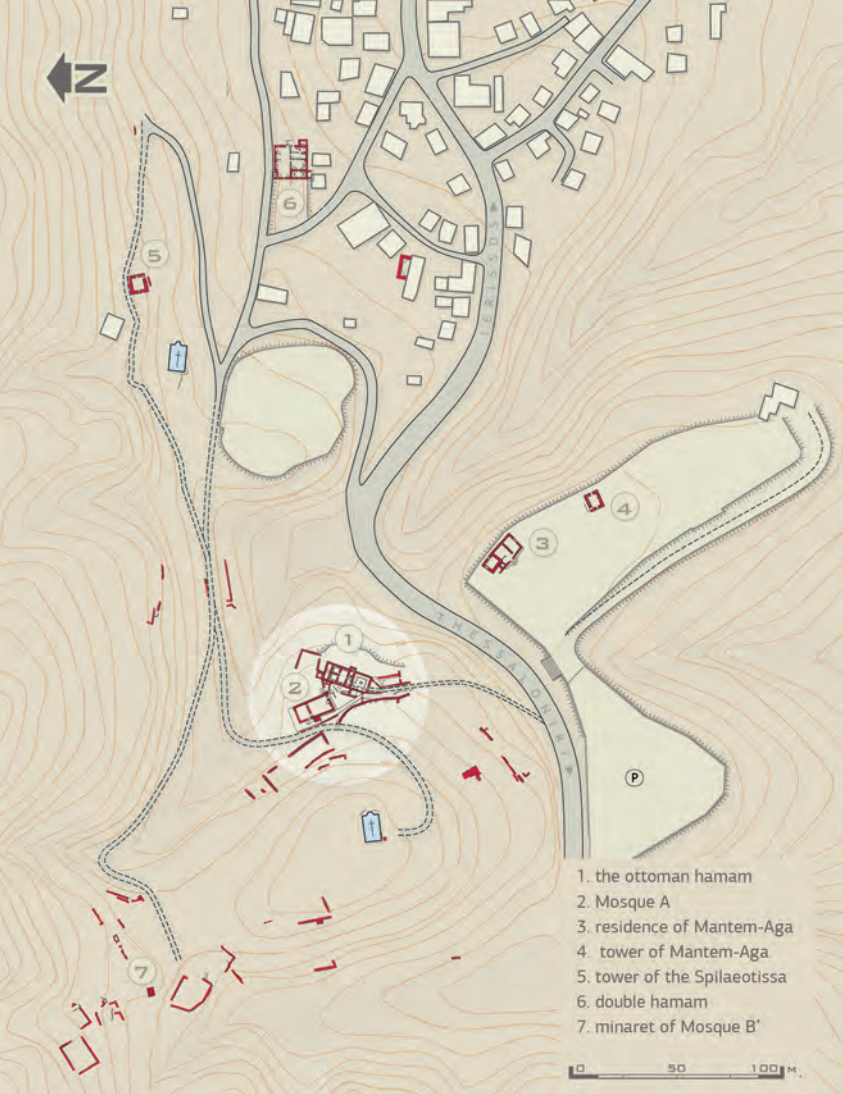
| cold-disrobing room ( <i>soyunmalik</i> ) | common-use hot room ( <i>sıcaklık</i> ) |
| tepid room ( <i>soğukluk</i> ) | private hot room ( <i>halvet</i> ) |
| auxiliary space | water tank ( <i>hazna</i> ) |
| restroom ( <i>tuvalet</i> ) | stoking space of the fireplace |

The bath consists of three lined-up functional spaces: on the south there is the square, cold, disrobing room (*soyunmalık*), subsequently, the elongated tepid section (*soğukluk*) and in the end the spacious hot room (*sıcaklık*) with two square private rooms (*halvet*). On the north side, there is the water tank (*hazna*) where the water was heated through a cauldron incorporated to the floor. Smoke was channeled from the fireplace through the flooring with a hypocaust system to heat the rooms. In the tepid and the hot rooms the walls were covered with a bicolor coating decorated with a line of stylized anthe-mions. The domes were decorated with embossed stalactites and star-shaped openings for lighting purposes.

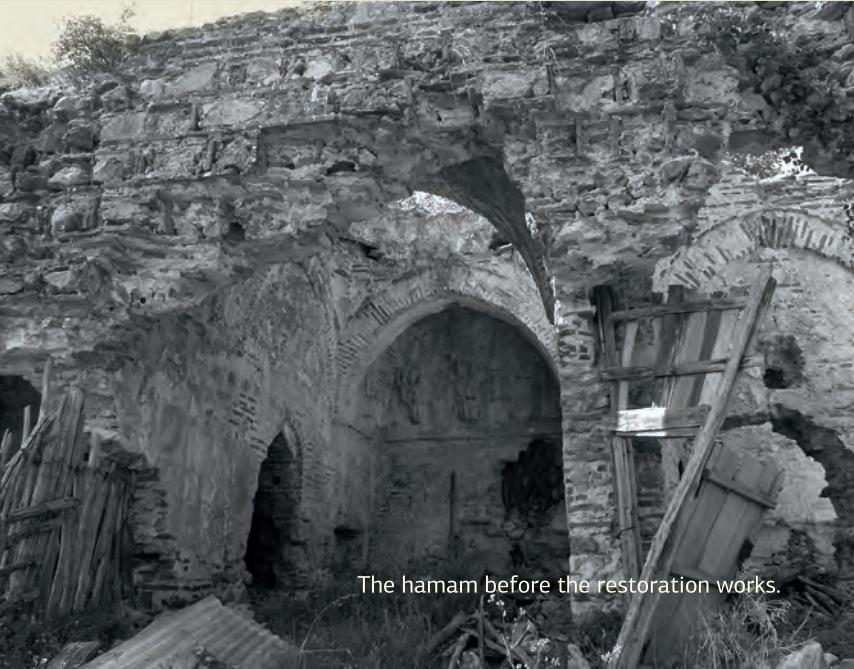
The hamam before the restoration works.

The Ephorate of Antiquities of Chalcidice and Mt Athos carried out the conservation works at the bath in the framework of the programme «Macedonia-Thrace 2007-2013». The bath was restored as an enclosed space with the exception of the cold room and the water tank. Consolidation and restoration works were done on the bath walls. The entrance, the stone-paved floor with the marble base of the fountain and the perimetric divan with niches to store the bathers' personal belongings were found in the cold room. In the hot rooms the domes were rebuilt and an independent metal floor with underfloor heating system was placed. Conservation and aesthetical restoration works were held on the inner wall decorations and also both the hypocaust and the heating-cooling installations were highlighted. Lastly, the retaining walls of the surrounding space were consolidated and restored.

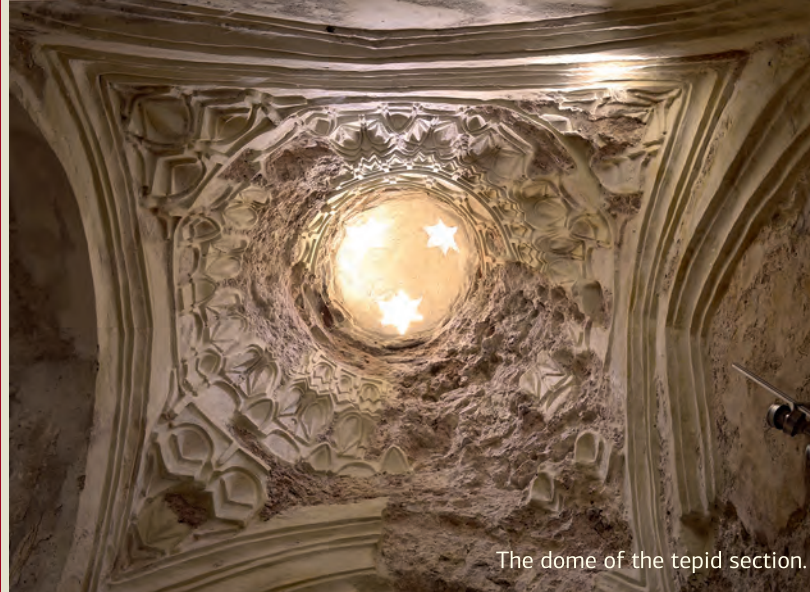
The dome of the tepid section.

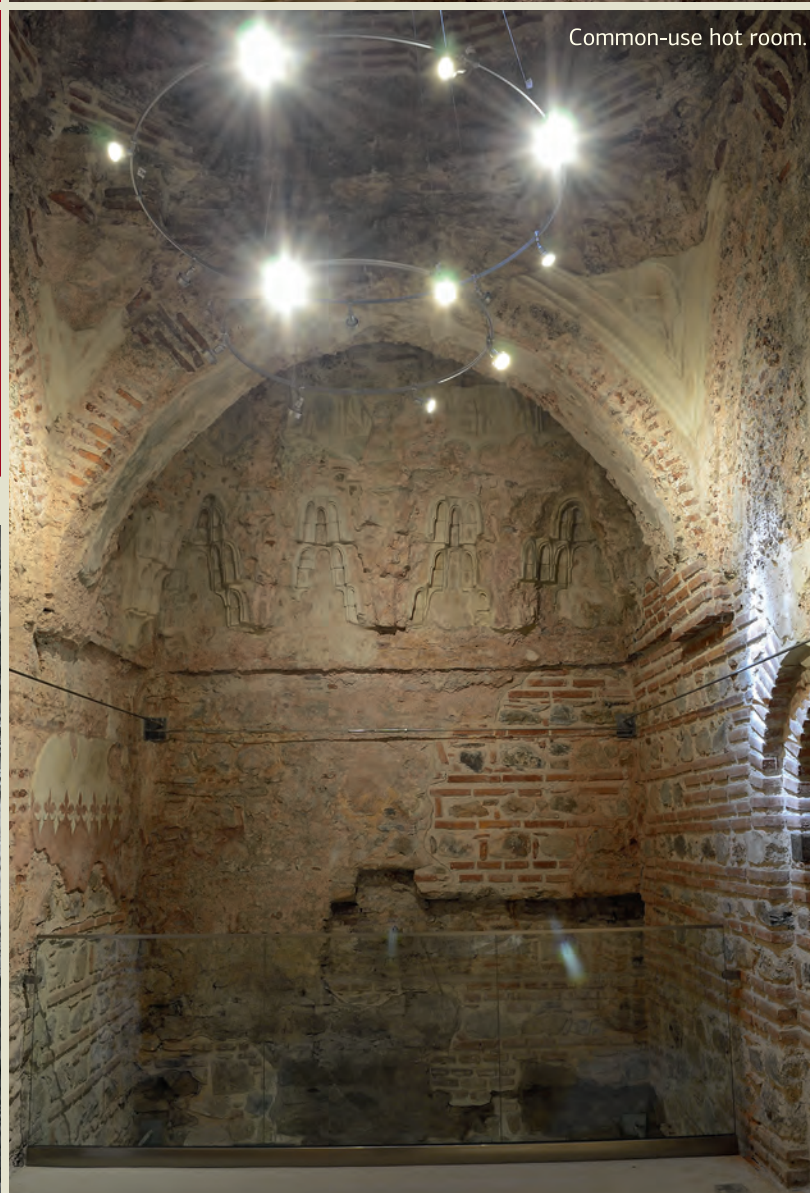
Common-use hot room.

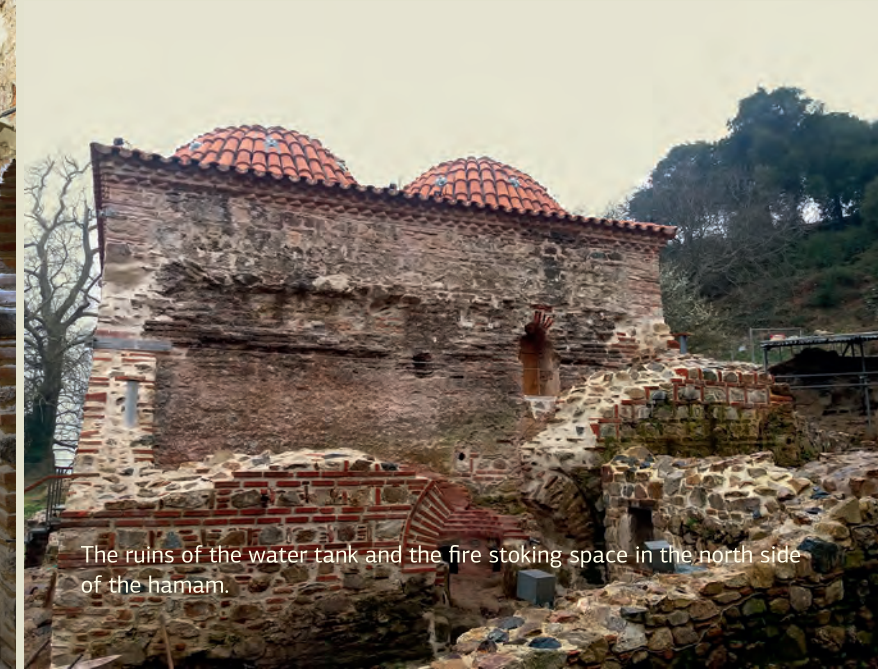
The ruins of the water tank and the fire stoking space in the north side of the hamam.
